N93-12776

SURFACE CONTAMINATION ON LDEF EXPOSED MATERIALS *

C. S. Hemminger
The Aerospace Corporation
El Segundo, CA 90245
Phone: 310/336-1619; Fax: 310/336-5846

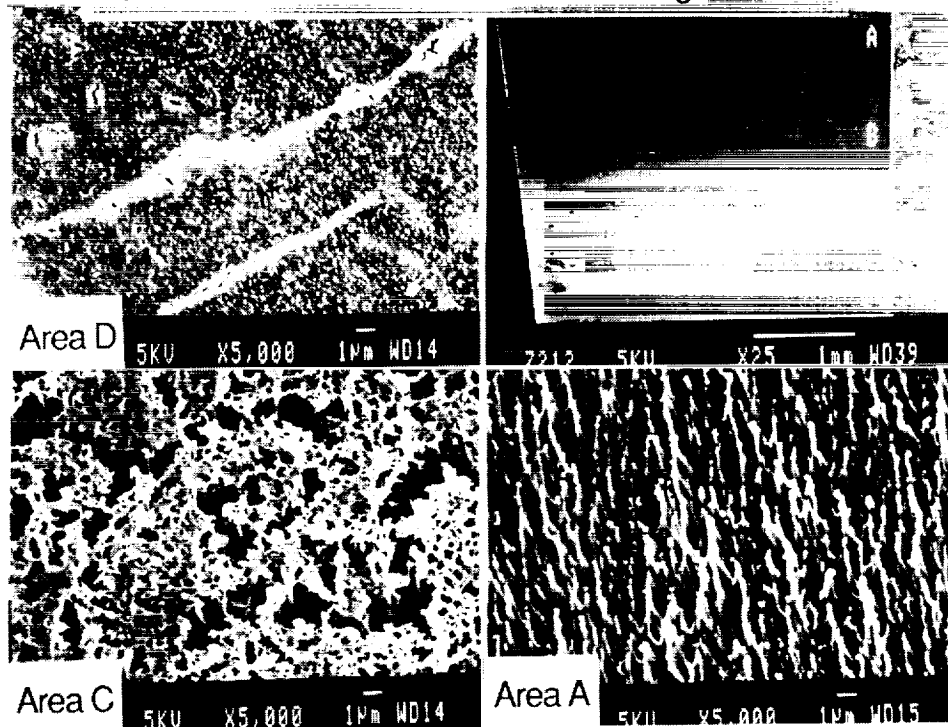
AO Erosion of A10 Thermal Blanket Edge Surface

The Ag/FEP thermal control blanket edges were contaminated, in many cases more than the exposed surfaces. Therefore, the masked edges did not provide good flight "control" samples. The transition zone from the exposed surface to the masked edge was particularly prone to contamination build-up. This was probably the result of the combination of high out-gas flux and radiation. The blankets were bent down around the edges of the tray so that the blanket edges were not rigorously shielded from radiation. SEM images from one transition zone, seen in Figure 4, showed that during atomic oxygen erosion of the FEP surface, undercutting of the contamination and damaged polymer layer played a role in the development of a clean, highly textured surface. Area A, at the periphery of the exposed surface, had a characteristic atomic oxygen erosion pattern. Area D, closer to the blanket edge, was a surface with contamination coverage and UV degraded FEP. Area C, in the center of the transition zone, showed undercutting of the contamination and damaged polymer layer by atomic oxygen erosion. The development of submicron particles of SiO_2 was observed on some edge surfaces by SEM/EDS, as seen in Figure 5. Such particle development was not detected on any of the other samples included in this study. Areas of orange/brown contamination were observed on some Ag/FEP edge surfaces near keyhole-shaped vent slots in the blanket edges. XPS analysis showed these stains to be high in carbon, sulfur, and nitrogen relative to other contaminated areas. The source of contamination was not identified, but it appears to have contained an amine/amide functionality.

Figure 4. SEM images of a transition zone on the A10 blanket edge. Area A has the characteristic atomic oxygen erosion pattern. Area D is a surface with contamination coverage and UV degraded FEP. Area C shows undercutting of the contamination and damaged polymer layer.

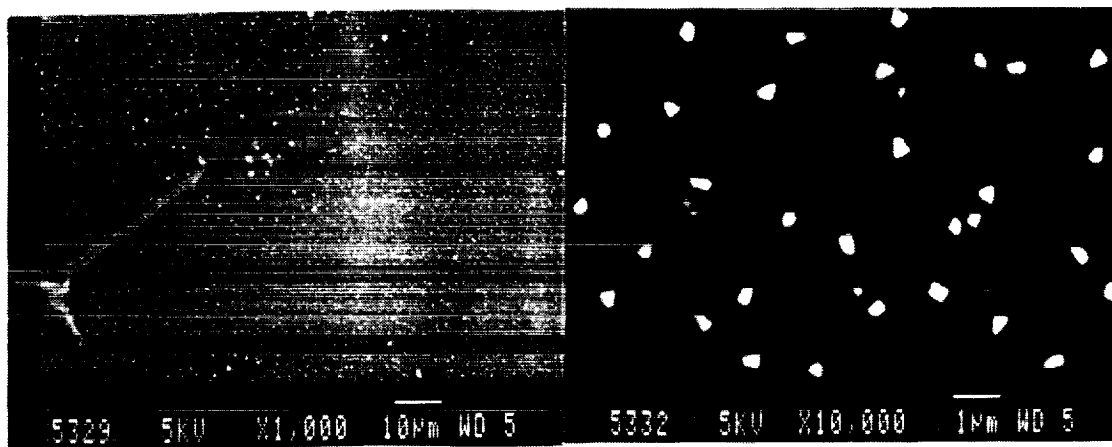
C8: UNEXPOSED EDGE

Figure 5. SEM images of submicron particles of SiO₂ on a masked edge surface of the C8 blanket.
